AUTHOR	Callahan, Michael P.; Parker, Danny S.
TITLE	Energy Efficient Florida Educational Facilities. Improvements to a Portable Classroom in a Volusia County School.
INSTITUTION	Florida Solar Energy Center, Cape Canaveral.
SPONS AGENCY	Florida State Dept. of Education, Tallahassee. Office of Educational Facilities.
REPORT NO	FSEC-CR-1008-98
PUB DATE	1998-06-00
NOTE	9p.
AVAILABLE FROM	Web site: http://www.fsec.ucf.edu/~bdac/pubs/CR1008
PUB TYPE	Guides - Non-Classroom (055) -- Reports - Descriptive (141)
EDRS PRICE	MF01/PC01 Plus Postage.
DESCRIPTORS	Air Conditioning; *Educational Facilities Improvement; Elementary Secondary Education; *Energy Audits; *Energy Conservation; Heating; Lighting; Public Schools; *Relocatable Facilities; *Research Projects; Roofing
IDENTIFIERS	*Florida

Energy Efficient Florida Educational Facilities
Improvements to a Portable Classroom in a Volusia County School

FSEC-CR-1008-98*
June 1998

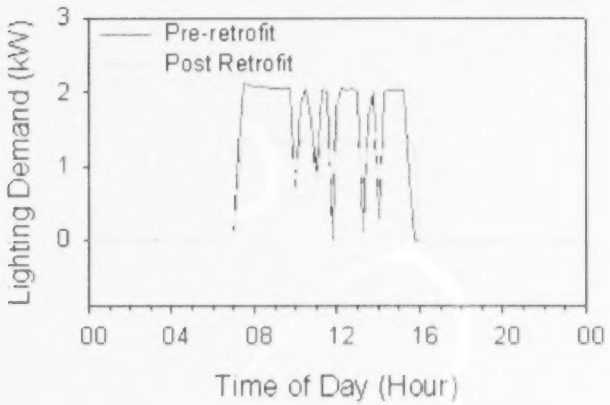
type of lighting system puts out a great deal of heat and is not as bright as the T8 lamps with electronic ballasts which they were replaced with. The old system also had greater energy consumption than did the new system as seen in Figure 2.

Figure 2. Graph of lighting demand over the course of a day for portable 035. Pre-retrofit average demand is 0.60 kW and post retrofit average demand is 0.45 kW.

The lighting energy comparison pre and post retrofit in Figure 3 highlights the energy savings. The average energy demand on May 20, 1998 prior to the retrofit is 0.60 kW while the average energy demand after the retrofit (May 27, 1998) is 0.45 kW. This represents a energy savings of 25%, which is higher than in previous studies (Sherwin and Parker 1996). This savings is considerable since the data shows that lighting energy for portable 035 is 26% for May 20 while on May 27 the energy use was only 19% of total portable energy use.

This is the concept behind retrofitting the lighting system in portable 035. The 24 fixtures in the with the old magnetic ballasts were replaced with 12 electronic ballasts. The F40CW T12 lamps were then replaced with F32 T8 lamps.

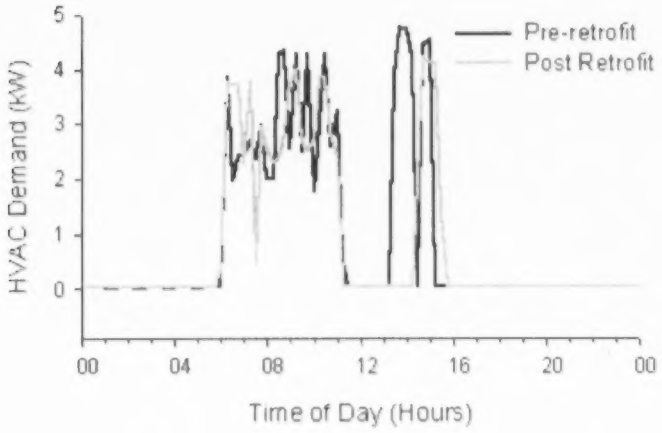
the pre-retrofit temperature, but that the total energy use by the AC system is 2.8 kWhs less (14%), even though the Bard unit is a 2.5-ton unit versus 3 tons for the old unit. Figure 6 also points out that through the hottest part of the day, the demand post retrofit was approximately 500 watts less than pre-retrofit.

Figure 5. AC energy demand data for two matched days. Pre-retrofit total kWh = 22.4: post retrofit total kWh = 19.6

On June 17th the existing Cripsaire AVP36HPA wall unit was replaced with the new 2.5-ton system with an energy recovery ventilator. It would be premature to attempt to analyze data from the AC retrofit, due to the school year ending before the recent installation. With the end of the school year and the subsequent install, the AC has either been turned off altogether or the schedule has changed significantly. When school resumes in late August and the AC is once again run for most of the day, a savings analysis can be performed. Figures 5 and 6 examine preliminary data for this retrofit. This data has been gathered from two matched days with very similar outdoor temperatures.

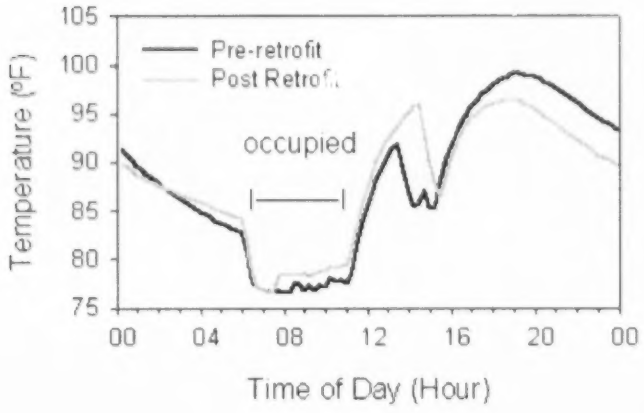
It can be seen that the average temperature within the portable post retrofit is very similar to

Figure 6. Interior air temperatuers for two matched days. Pre-retrofit average temperature =

88.09: post retrofit average temperature = 88.13
